Static and Fatigue Testing of Mechanical Life Extension Options for Plates Containing Elongated Holes

R. L. Evans and M. Heller DSTO-TR-1202

DSTO-TR-1202

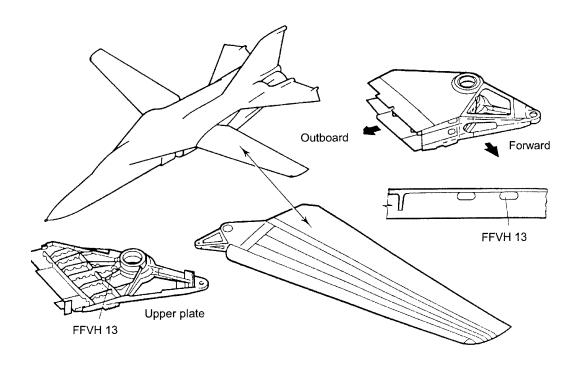
Figure 1. F-111 aircraft and wing showing the location of fuel flow vent hole number 13 (FFVH 13) in the wing pivot fitting (WPF).

The wing pivot fitting (WPF) is a primary structural component in the F-111 wing and has been the site of fatigue cracking in service and structural failures during cold proof load testing (CPLT)¹. The WPF assembly, as shown in Figure 1, consists of an upper and lower plate with integrally forged stiffeners, which are welded together to form a box structure which transmits concentrated wing loads through a pivot pin. It is made of high strength D6ac steel that has low fracture toughness, hence it is sensitive to fatigue cracking in areas of high stress concentration. The main locations at which cracks have occurred are geometric features in the WPF upper plate stiffeners, known as fuel flow vent holes (FFVHs) and stiffener runouts (SROs). In terms of the FFVHs, the most frequent location of cracking has been at FFVH 13, however cracks have also been detected at FFVH 11, 12 and 14.

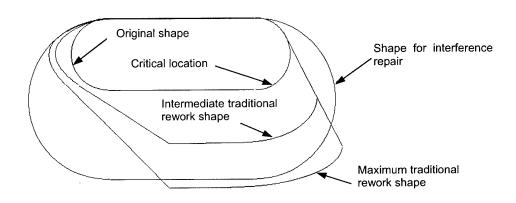
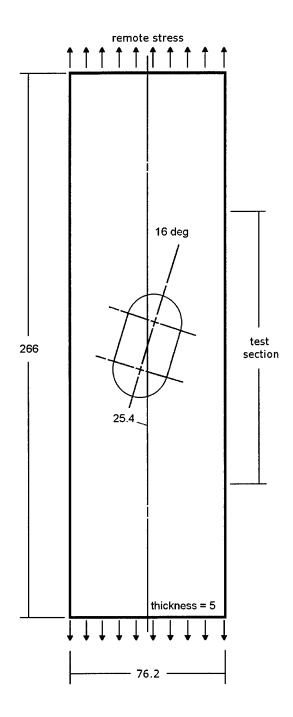
Figure 2. Comparison of the original (i.e. blueprint) geometry of FFVH 13 with typical RAAF rework shapes and proposed hole for interference-fit plug.

regular precautionary process called confidence polishing². However, these non-precise procedures have generally resulted in a large range of ill-defined FFVH shapes in the F-111 fleet. For the removal of 'long' cracks, AMRL developed a family of rework shapes for FFVH 13, [3]. Such a typical intermediate rework shape is shown in Figure 2. These shapes primarily addressed the stress concentration at the lower inboard corner of FFVH 13 by increasing the radius of curvature at that location, with the intention of reducing the peak residual tensile stress as well as the cyclic stress at this location. Fleet wings were reworked to a member shape of this family when a 'long' crack was detected in maintenance (small cracks were blended out by hand applied abrasion). A member shape was selected that was just large enough to completely remove the crack. The rework was manufactured using electro-discharge machining. It has been demonstrated by FE analysis and full-scale test that the family of standard FFVH 13 rework shapes gives a reasonable stress reduction at the critical lower inboard corner location. Unfortunately, the recent DADTA results, mentioned above, show that the stress reduction is not sufficient to produce an acceptable inspection interval. Also, there has been a recent instance of a crack at FFVH 13 in an F-111C wing, despite a rework shape similar to that shown in Figure 2 having been implemented previously in that wing3. These circumstances indicate that the current management strategy for FFVH 13, using the current rework shapes, is not sufficient to provide both an acceptable safe inspection interval and sufficient durability to the PWD.

The blueprint configuration had an elongated hole of the same geometry as was originally present in the FFVH 13 location in the F-111 (refer to Figure 2). The geometry of the plate specimen is shown in the engineering drawing of Figure 5. The hole has an aspect ratio of 3:1, being 38.1 mm (1.50 in) long and 12.7 mm (0.50 in) wide. Apart from providing a comparison to the open-elongated-hole specimens, some of these specimens were used in preliminary static testing to determine the exact representative CPLT remote loading for all tests, as discussed further in Section 3.2. Four specimens were manufactured and tested. The test section as indicated in Figure 3 was 118 mm for the first two specimens, and then 95 mm for the last two specimens to ensure that buckling did not occur. This choice was based on prior work, which indicated that the test section of a typical FFVH specimen should preferably be less than 110mm to maximise the buckling load [16].

For the interference-fit plug option there has been a significant degree of prior work. The concept is to accurately machine a non-circular hole to a size similar to the maximum AMRL rework shape as shown in Figure 2, for subsequent cold-expansion and interference-fitting. This would allow the repair to be applied to most holes in the fleet, irrespective of their current shape. The ability to cut such a hole with a high degree of accuracy has been demonstrated on an actual F-111 wing in prior work at AMRL, [6]. Here an advanced electro-discharge machining procedure was used. It is worth noting that interference fitting and/or cold expansion of circular holes are highly effective and well-known approaches [7, 8, 9], whereas the non-circular case is a relatively new concept. Two-dimensional finite-element analyses have recently been used to investigate the typical stresses for the non-circular hole enhancement [10, 11]. This work indicated that enhancement through combined cold expansion and interference fitting should be considerably better than interference fitting alone. Also in this work, plate stress distributions measured experimentally due to elastic interference-fitting to a level of approximately 0.74%, compared well with the finite-element predictions. This demonstrated the suitability of a proposed AMRL tapered plug/sleeve design to achieve effective elastic interference-fitting of an elongated hole. Cold-expansion testing of non-circular elongated holes using this proposed plug has also recently been undertaken [12]. Nominal expansion levels of greater than 2.5% were achieved along with maximum peak strains of more than 10,000 με and maximum residual strains of greater than 1600 µE, indicating highly effective cold expansion. It was also demonstrated that subsequent to cold expansion, interference fitting could be achieved without the need for post cold-expansion machining. Fatigue testing of the plug/sleeve assembly (with minor design revisions) was recommended to confirm its suitability as a highly effective option for extending the fatigue life of the FFVH 13 region of the F-111 aircraft.

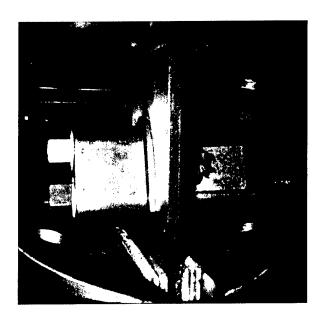
Figure 18. Interference-fit plug specimen 2 during fatigue testing.

The data presented in Table 4 clearly shows the excellent life extension improvement provided by the interference-fit plug. For the fully expanded specimens 2, 3 and 4, fatigue testing was terminated at 68.95 blocks (i.e. 137,652 flying hours) and the steel plate was statically failed after removal of the plug assembly. No cracks were detected in these specimens. The testing of specimen 1 was terminated at 32.71 blocks (i.e. 65,302 flying hours). Two small cracks were detected after static failure of this plate specimen, noting that the hole was not fully expanded. In all fatigue tests it was found that the interference-fit plug assembly moved to some extent within the elongated hole of the steel plate (even though the bolts remained tight). For specimen 3 the plug assembly was even slightly *inside* the sleeve flange (i.e. the insertion distance was negative (-0.25 mm) at block 59). Hence for any future practical implementation of this option, it is probably desirable to ensure locking of the plug with respect to the plate, after full plug insertion has been achieved. The plug assembly demonstrated very good structural integrity, surviving without damage (except for minor fretting) for more than 137,000 simulated flying hours.

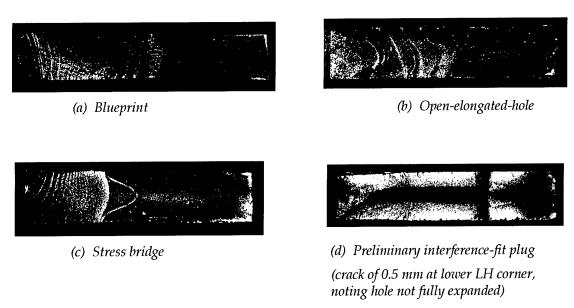
Figure 21. Photograph of typical fracture surfaces of each of the four specimen types (where specimen thickness is 5 mm).

Fractographic work was performed on each of the four specimen types, [19]. Photographs of the typical fracture surfaces can be seen in Figure 21. The photographs (a, b and d) are of crack 1 which is located at the critical strain gauge 1 position (refer to Figure 4). The stress-bridge photograph (c) is of crack 2 (critical strain gauge 3 location).

As can be seen from the photograph (Fig. 21a) and graph (Fig. 22) of the blueprint specimen type (specimen 3), the crack growth rate is initially high, with the crack initiating almost immediately, and then gradually reducing. This is expected to be due to two factors (i) the high residual tensile stress resulting from the CPLT, which are a maximum close to the hole boundary, and (ii) the fatigue loading which is dominated by compression. It is worth noting that the fractography data for the blueprint specimen type has been used in the validation of advanced fatigue crack growth modelling software. Figure 22 shows that the open-elongated-hole specimens have a very fast crack growth rate compared to the blueprint specimens. This is due to the higher value of $K_t = 4.2$ as compared to $K_t = 3.8$ for the blueprint specimens. Due to this higher K_t value, the magnitude and size of the detrimental residual tensile stresses (compressive strains) would be increased by the CPLT loading, as seen from the strain data (in Appendices A and B).

All of the stress-bridge specimens experienced significant cracking, as indicated in Table 4. In some cases cracking occurred at the anticipated open-hole critical location and in others it occurred elsewhere. For example, the largest cracks for specimens 1 and 3 were located adjacent to the clamping pads of the stress bridge. Figure 23 shows the extent of cracking of stress-bridge specimen 1, (the hole is distorted due to static failure of the plate and is cut to aid fractography). It can be seen that the clamping pads by design inhibited a large crack from growing in the crack 1 location, however crack 2 was 10.9 mm long. Also, the pads caused extremely large cracks to grow that were initiated by fretting. For example, crack 3 is 31.9 mm long.

All three interference-fit plug specimens that were fully expanded (i.e. to greater than 3%) had no detectable crack (at 500x magnification), which represents an excellent result. The interference-fit plug specimen 1, that was not fully expanded (i.e. 2.4%), had two extremely small cracks. Hence this fracture surface is only given in Figure 21, for completeness.

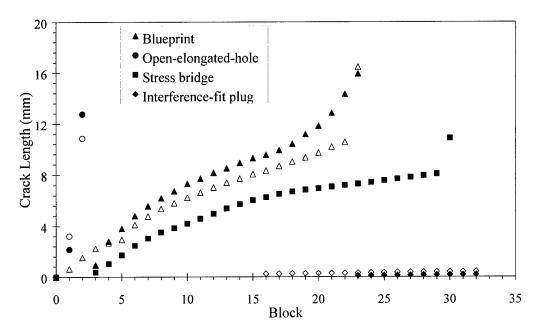
Figure 22. Sample crack growth results, with open symbol for crack 1 and solid symbol for crack 2, (noting that interference plug results are for preliminary case where hole was not fully expanded).

Crack growth data for cracks 1 and 2 are presented graphically in Figure 22. Each crack was measured from its origin to the maximum point at the start of the CPLT (excluding the initial CPLT) i.e. in blocks, and is presented in Table 4. A more detailed analysis of the fractography of these FFVH 13 fatigue specimens has been undertaken, [19].
